GLENWOOD LAKE DAM

NDI ID NO. PA-00327

PHASE I INSPECTION REPORT
NATIONAL DAM INSPECTION PROGRAM

JULY 1981

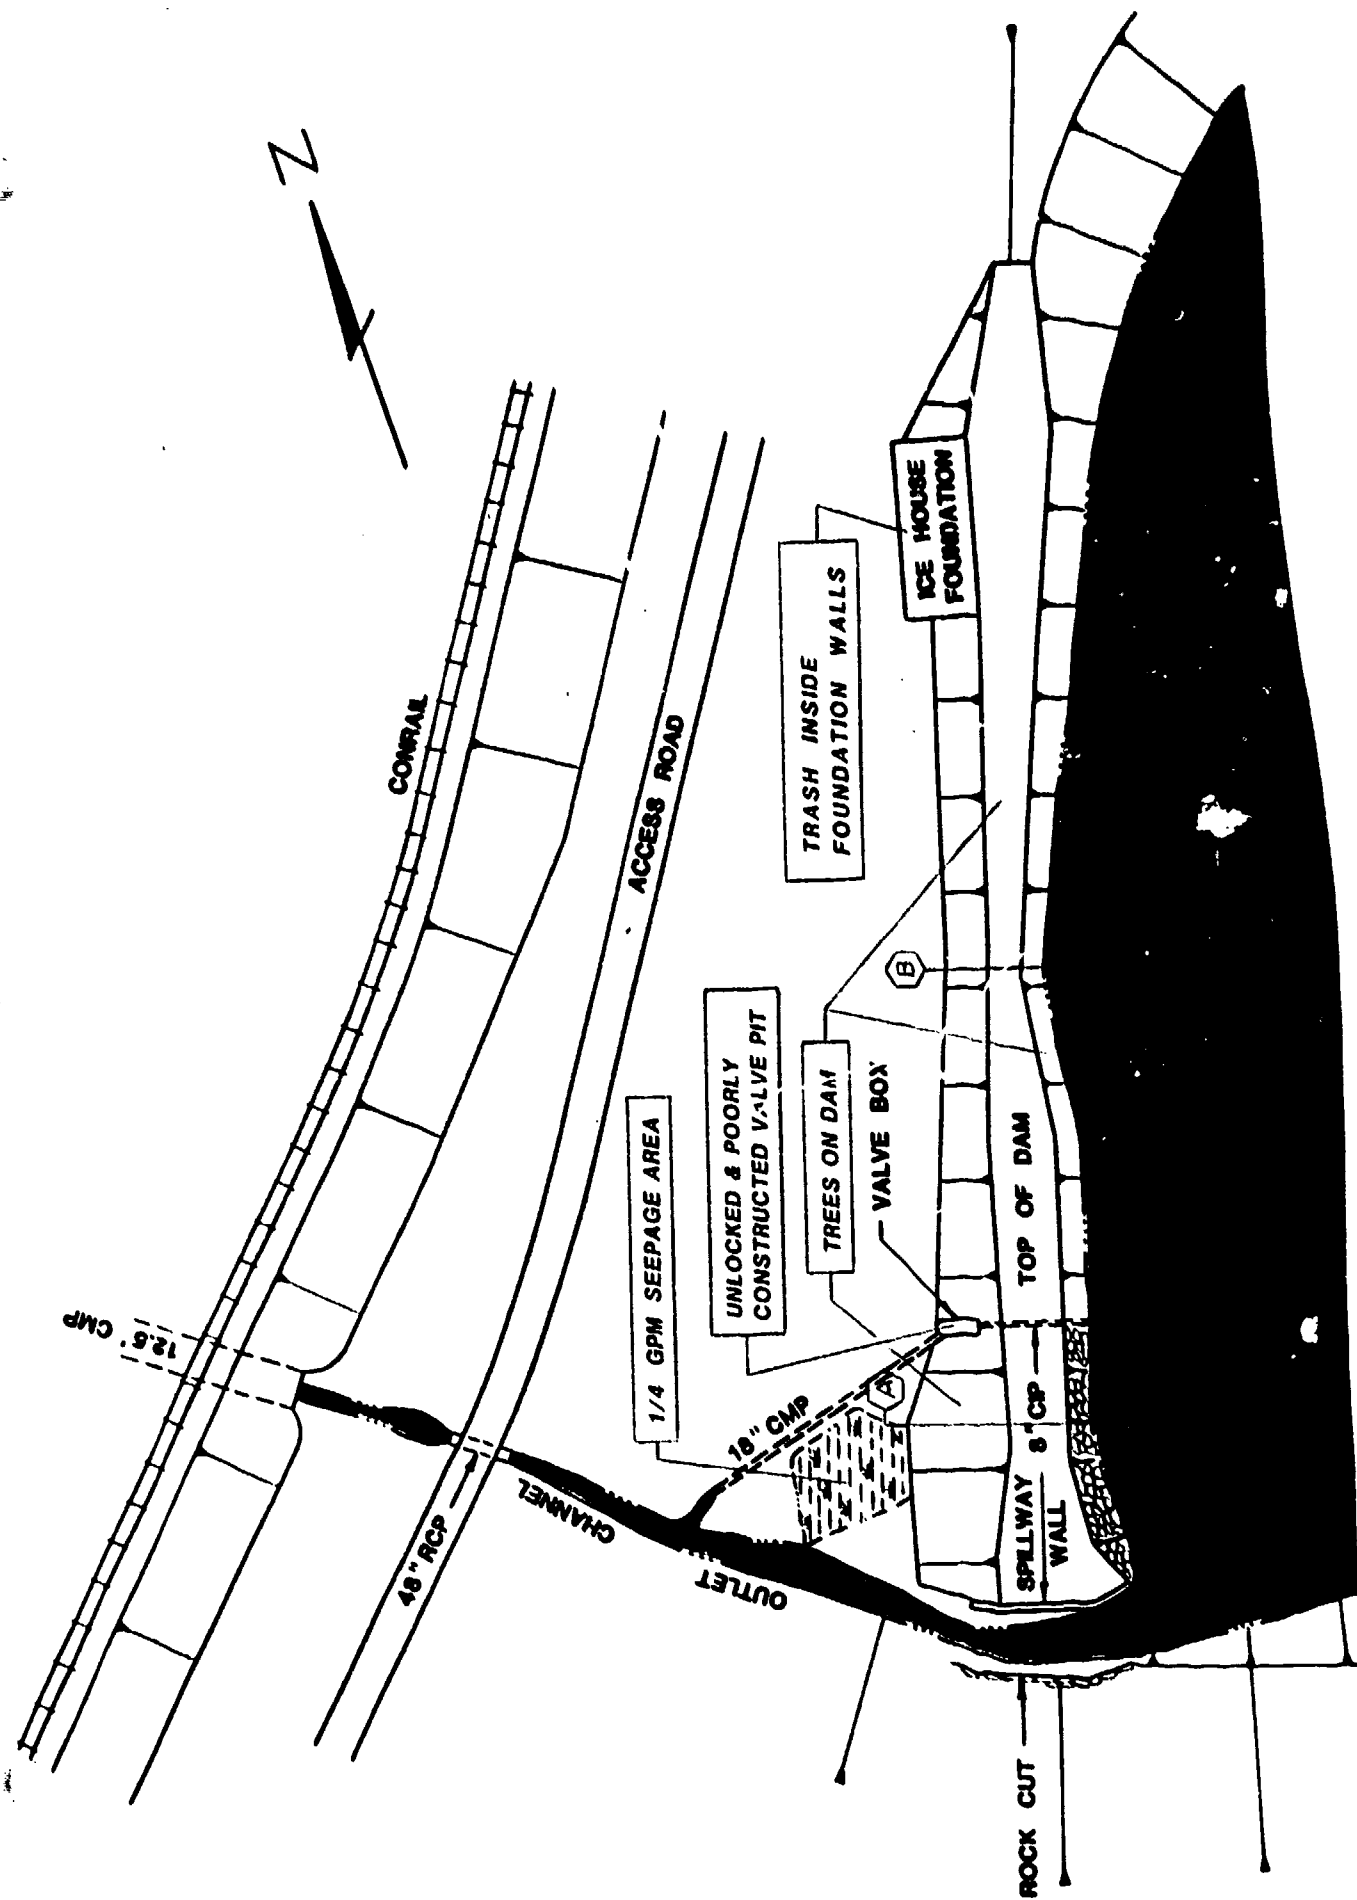
GLENWOOD LAKE DAM **GENERAL PLAN - FIELD INSPECTION NOTES**

a. General: The overall appearance of the dam is very poor. The locations of observed deficiencies are shown on the General Plan presented in Exhibit A-1, Appendix A. The profile and typical sections of the dam are presented in Exhibits A-2, A-3, and A-4 and are based on field survey made on the day of the inspection (12-09-80). The survey datum for this inspection is elevation 754.6 feet above mean sea level, derived by interpolation of USGS contour lines for the low point on the spillway crest (see Exhibits E-1 and A-2). Deficiencies observed during the field inspection are described below, and are illustrated in Exhibit A-1, Appendix A. Visible features are depicted in photographs presented in Appendix C.
